## **Информация по безопасности полетов № 12**

29.06.2015 в аэропорту Домодедово произошел серьезный инцидент с ВС Боинг-737-500 VP-BYT ОАО «Авиационная компания «ТРАНСАЭРО».

**737-SL-09-003-A**

**SUBJECT:** 737 NOSE GEAR COLLAPSE POTENTIAL DURING  
TOWING/PUSHBACK

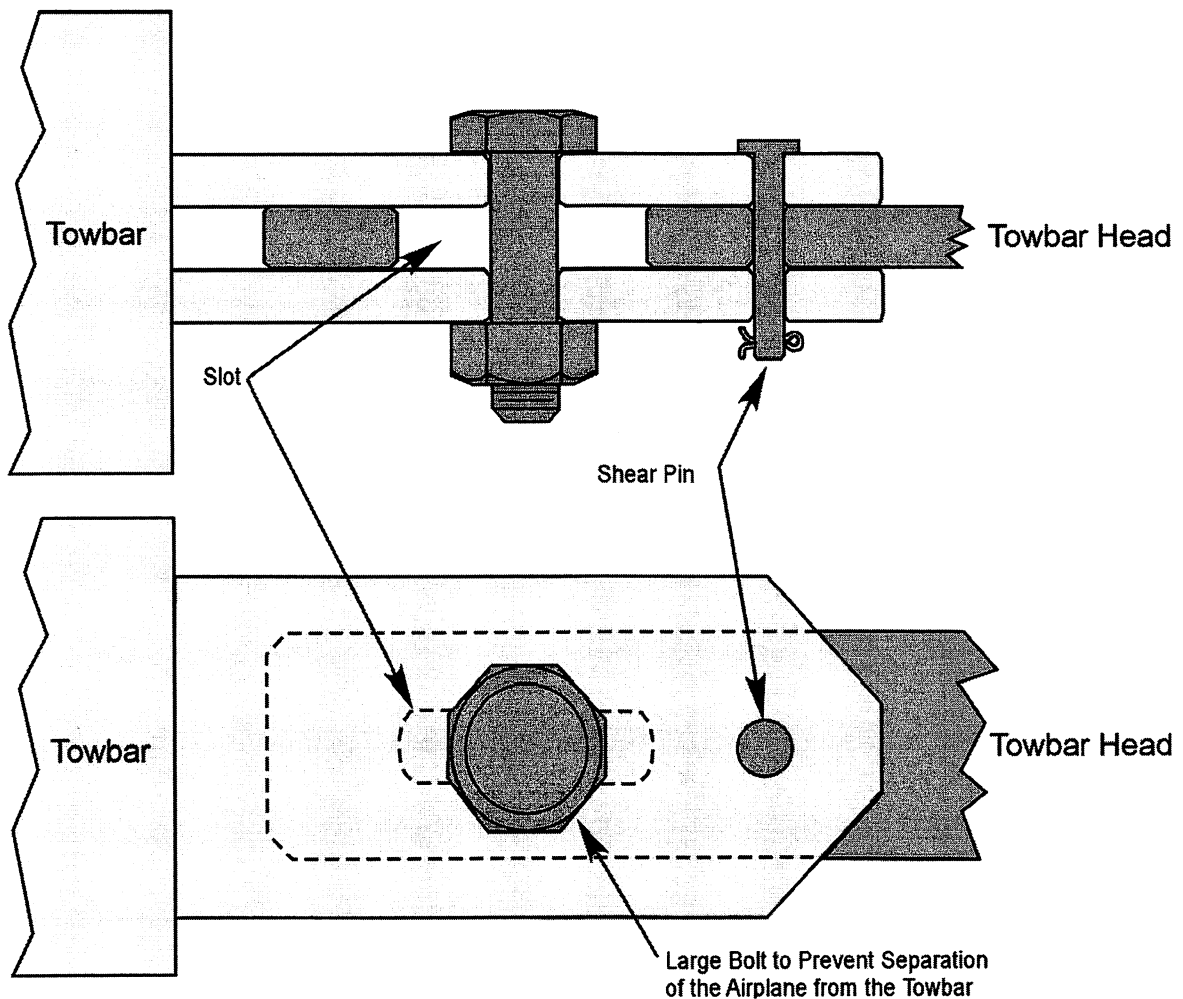
## ATTACHMENT 1

A review of the towbars used in the above service events revealed that they contained both features discussed above. For these towbars, the feature discussed in the second bullet consisted of a large diameter retention bolt in a slot. Refer to Attachment 1 which shows the conceptual design of the towbar shear protection in the above events.

If the shear pin in this design operates (shears), the lugs on the towbar and towbar head can move relative to each other thereby relieving the load, but only until the large diameter retention bolt reaches the end of the slot, at which time the full loads from the tug are imparted into the nose gear structure. It is our belief that the retention bolt most likely reaches the end of the slot too rapidly for a tug operator to react appropriately.

Boeing understands that it is desirable to not allow an airplane to become disconnected from a towbar if the shear device operates. However, it appears that the method suggested by the reference b) ARP, and used by many towbar manufacturers, effectively defeats shear protection for fore-aft loads. This feature (a large retention bolt in a slot) can result in excessive loads reaching the nose gear structure. Boeing believes that due to this design feature, many commercially available towbar designs do not adequately comply with the reference a) Boeing requirements.

- 5) Ensure that the correct shear pin is used for the application.
- 6) Contact towbar manufacturers about alternative designs that will adequately prevent unacceptable loads from reaching the nose gear.
